# Manhole Inspection Summary

Manhole # S43C2\_027MH

Insp Date: **12/14/07 12:28 PM**

**Location** Address: **1137 Monroe Cir**

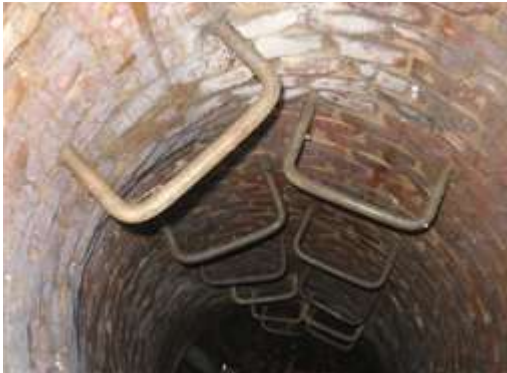
Steps

**Steps** Count: **11** Missing: **0** ☐ Corroded

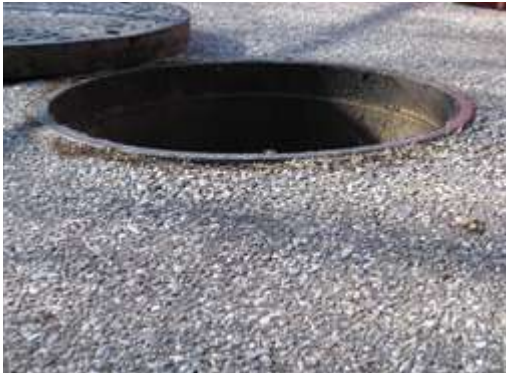
Defect 2

Above ground

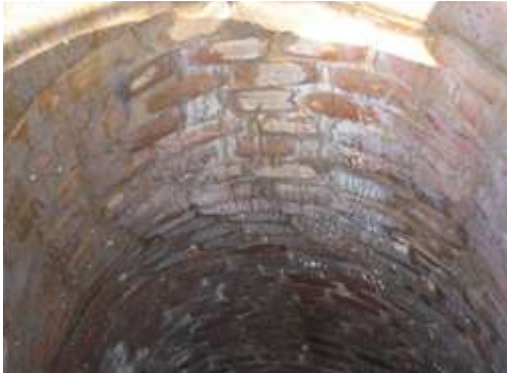
Defect 1

Infiltration: ☐ None ☐ Joint ☐ Cracks ☐ Mortar ☐ Roots ☒ **Wall**

Wall

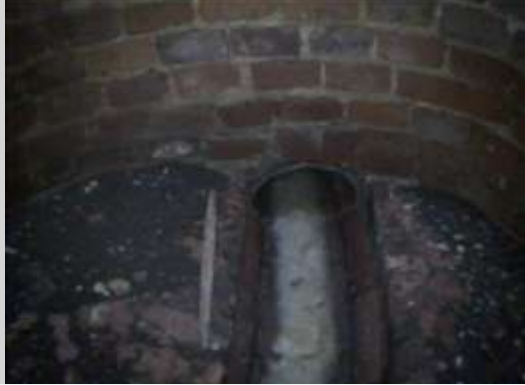
12 O'Clock Outflow

8 in. Circular Gravity Sewer  
Pipe Out @ 12 O'Clock

Infiltration: **None** Pipe Seal Cond: **Sound**

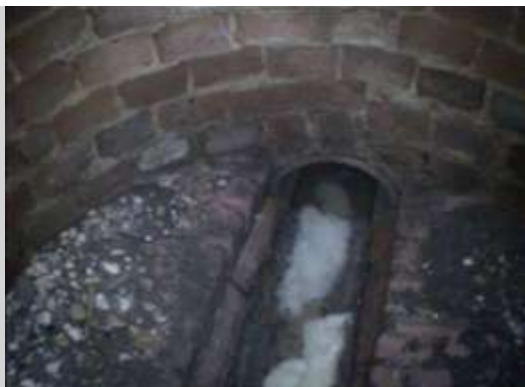
6 O'Clock Inflow

8 in. Circular Gravity Sewer  
Pipe In @ 6 O'Clock

Infiltration: **None** Pipe Seal Cond: **Sound**
